**Technical Report – R19481 - Rev 1**  
**CWCT – Standard for systemised building envelopes – 2005**

**Hilti GB**  
**MTF-MFI-1L Rail System**

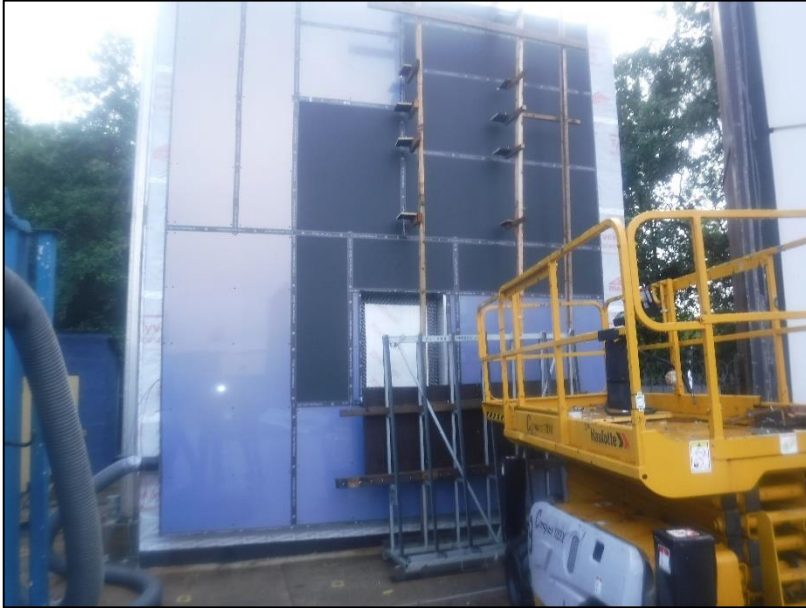
Photograph No. 1

**Sample during testing**

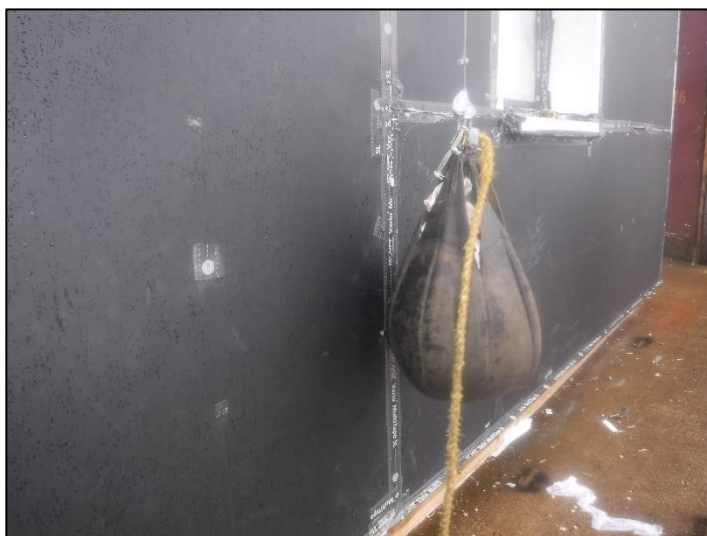
Photograph No. 3

Showing Soft Body (S1) impact of 120Nm.

During the above test, no damage was observed.

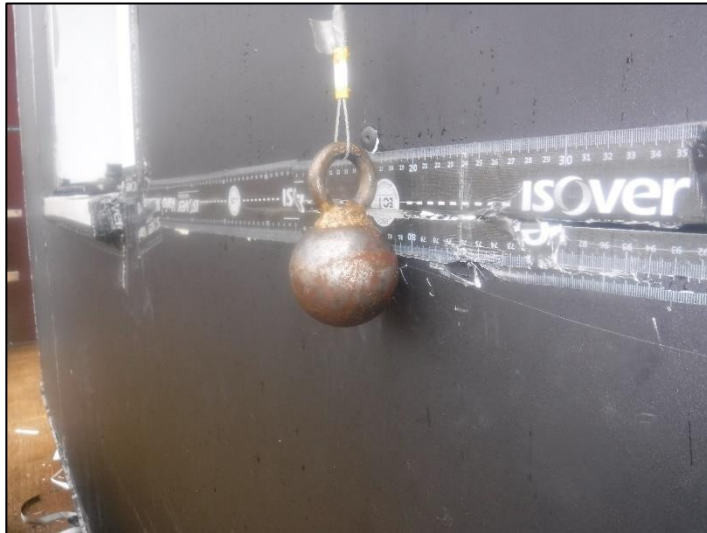
Photograph No. 4

Showing Hard Body (H2) impact of 10 Nm.

During the above test, no damage was observed.

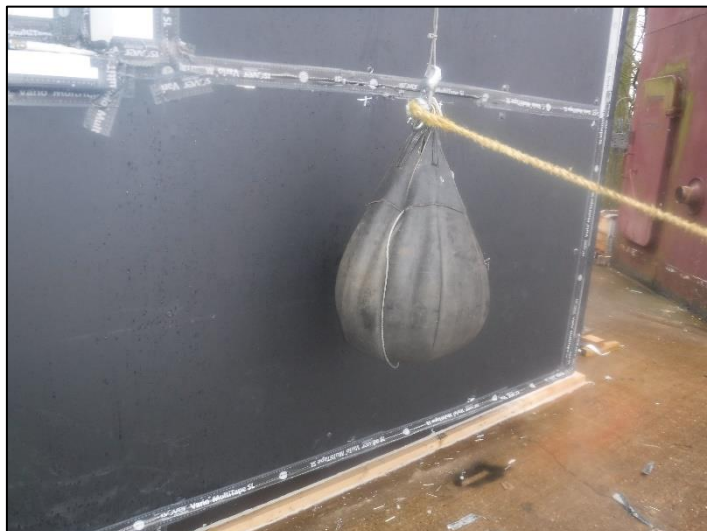
Photograph No. 5

Showing Soft Body (S1) impact of 500 Nm.

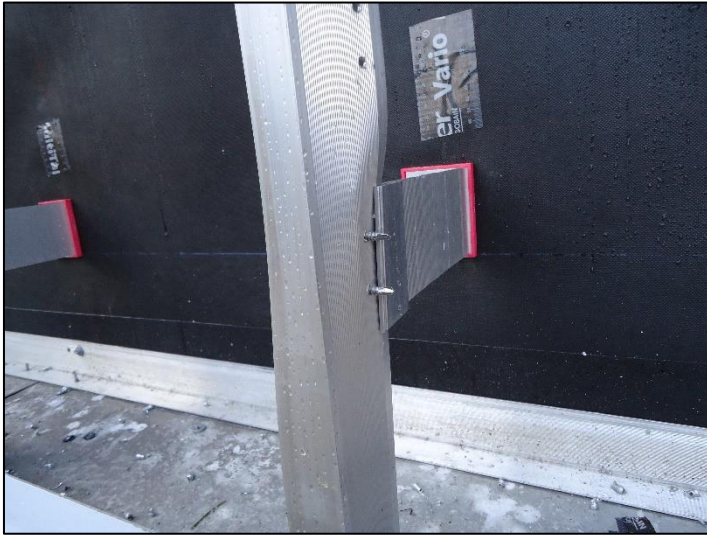
Photograph No. 6

Showing damage caused following Soft Body (S1) impact of 500 Nm.

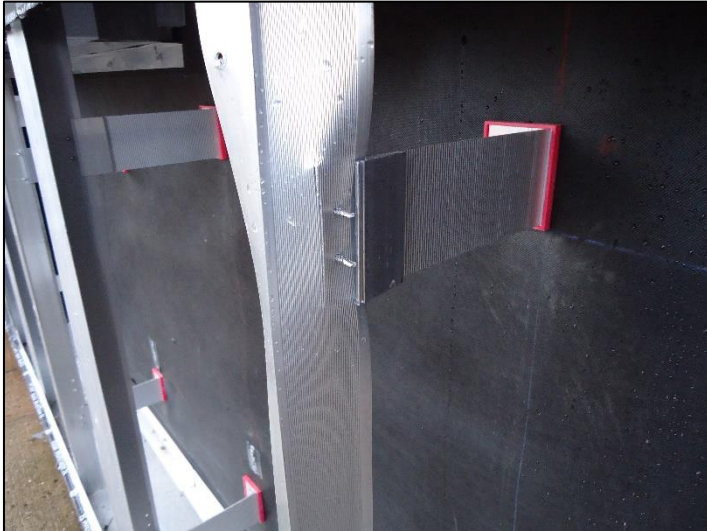
Photograph No. 7

Showing damage caused following Soft Body (S1) impact of 500 Nm.

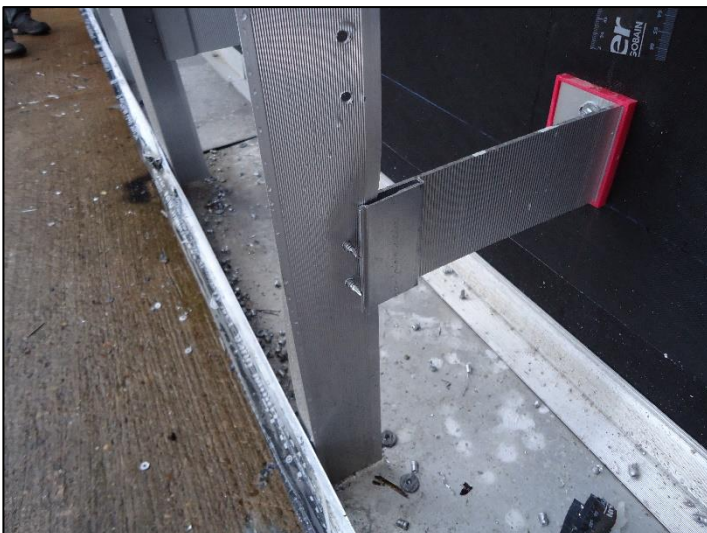
Photograph No.8

Showing damage caused following Soft Body (S1) impact of 500 Nm.

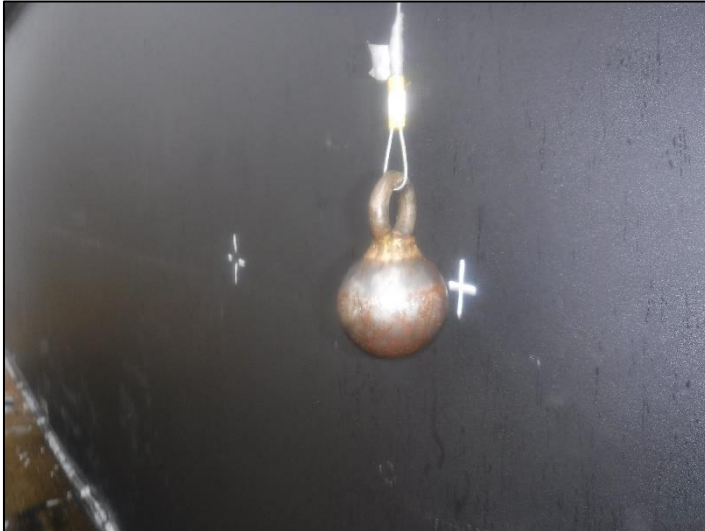
Photograph No. 9

Showing Hard Body (H2) impact of 10 Nm.

During the above test, no damage was observed.

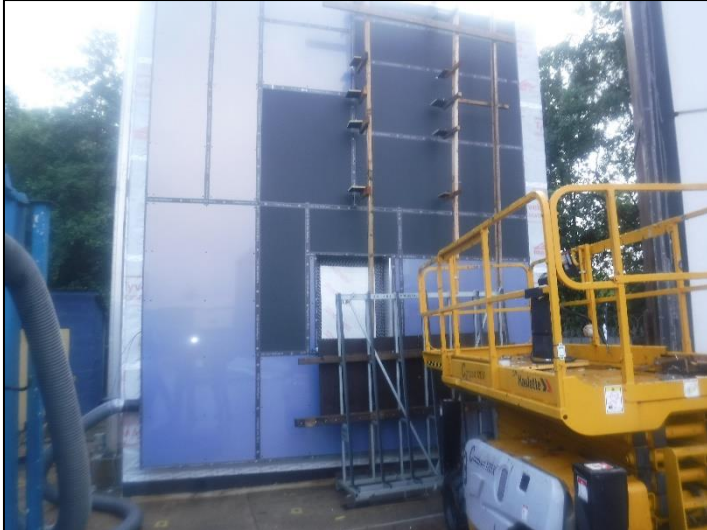
Photograph No. 10

Sample prior to dismantle

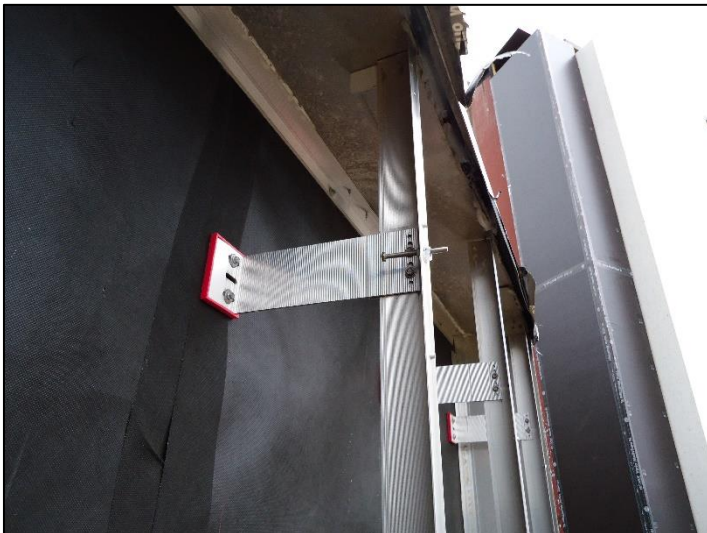
Photograph No. 11

Vertical support rail with bolt positioned for deflections

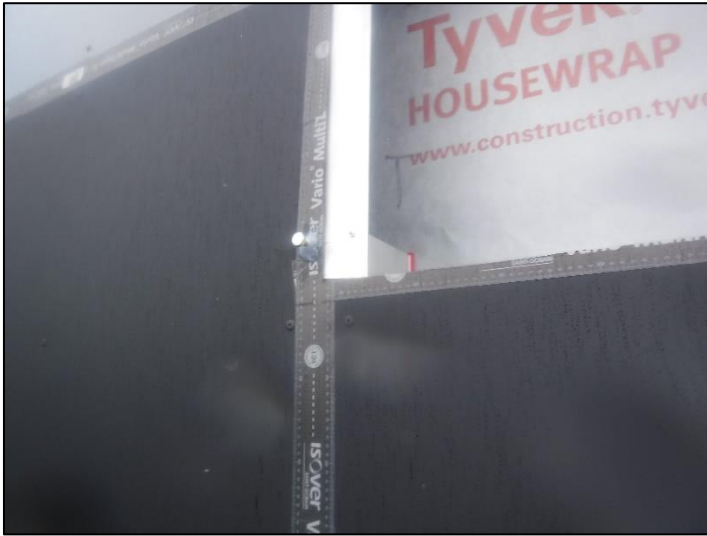
Photograph No. 12

Showing panel removed with positioning of bolt used to measure deflection on bracket

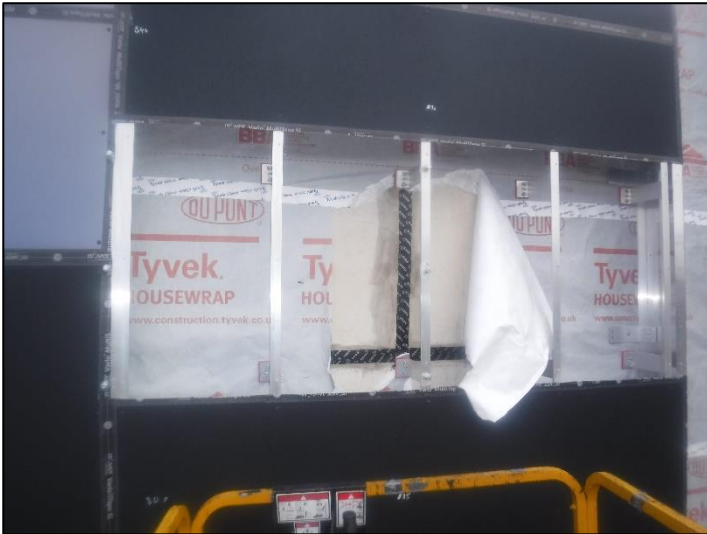
Photograph No. 13

Panel removed showing support rails location where bolts were installed for measuring during testing

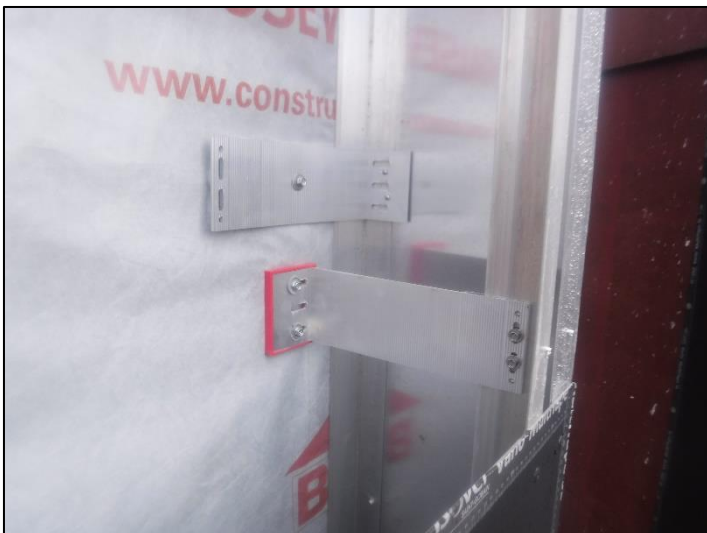
Photograph No. 14

Helping hand brackets and rails

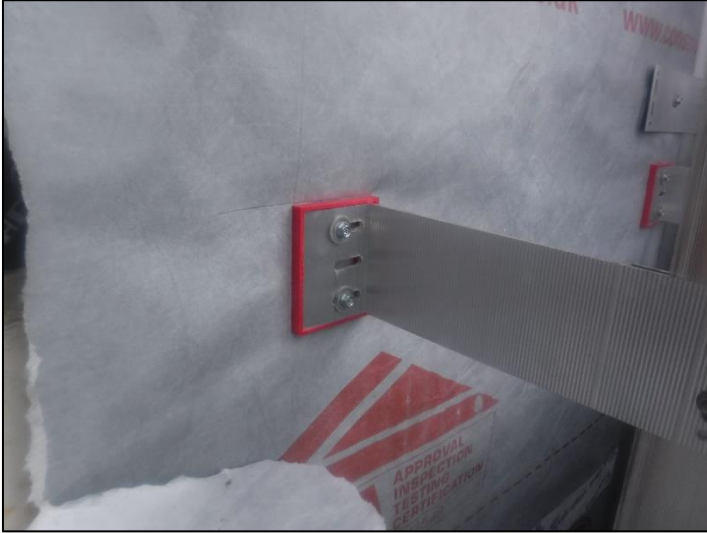
Photograph No. 15

Helping hand bracket  
connection to SFS backing wall

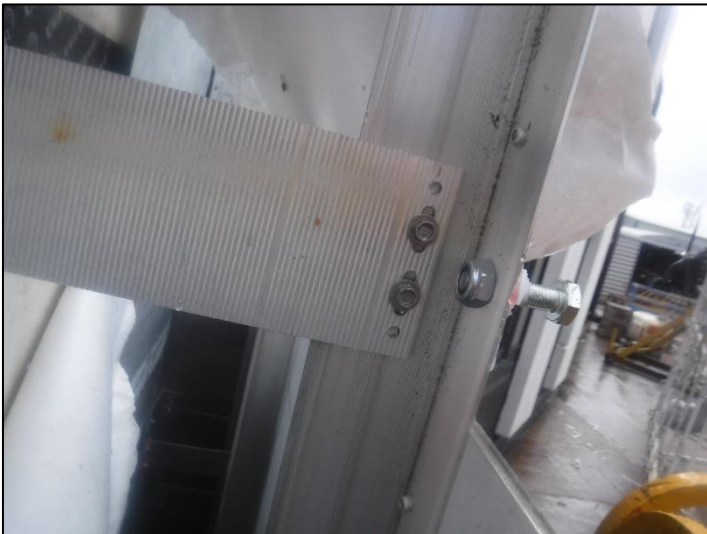
Photograph No. 16

Helping hand bracket connection to  
vertical rail and bolt positioned for  
measuring during testing

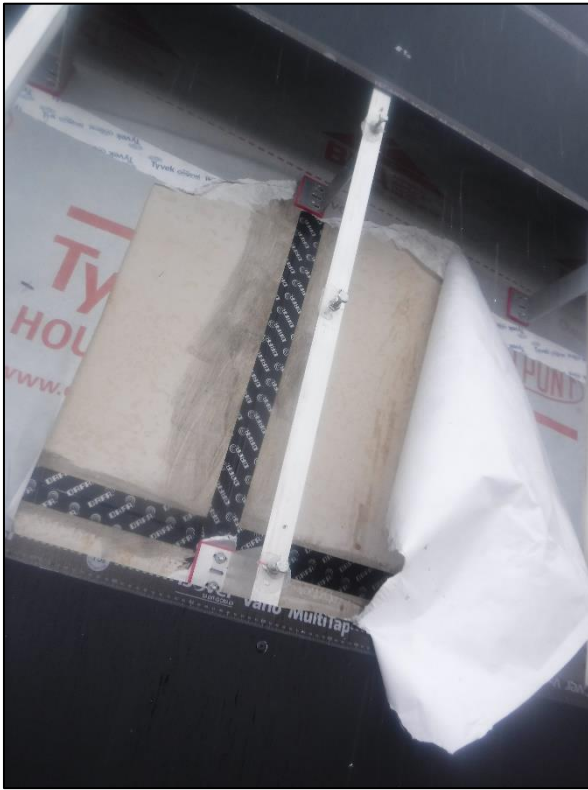
Photograph No. 18

Vertical support rail and bolts positioned for measuring during testing

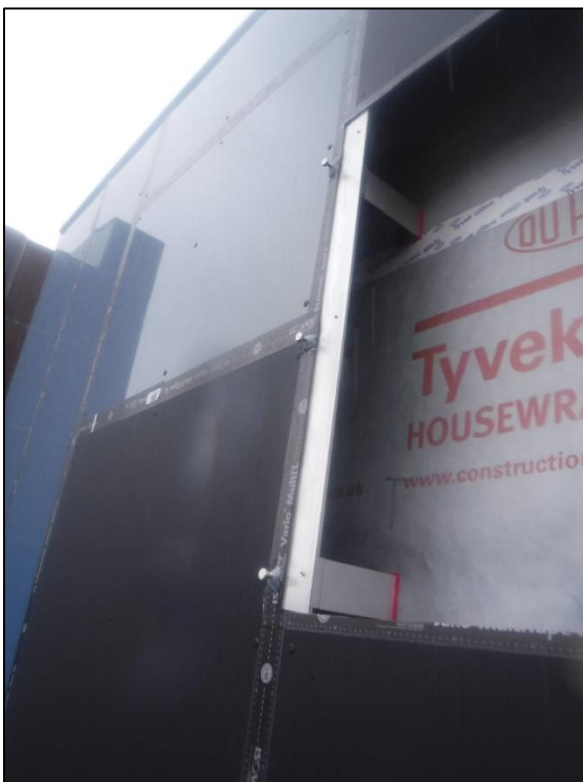
Photograph No. 19

Vertical support rail and bolts positioned for measuring during testing
